CCVT Failures and Their Effects on Distance Relays

Sophie Gray, *CenterPoint Energy*

Derrick Haas and Ryan McDaniel, *Schweitzer Engineering Laboratories, Inc.*
2350 NE Hopkins Court, Pullman, WA 99163 USA, +1.509.332.1890

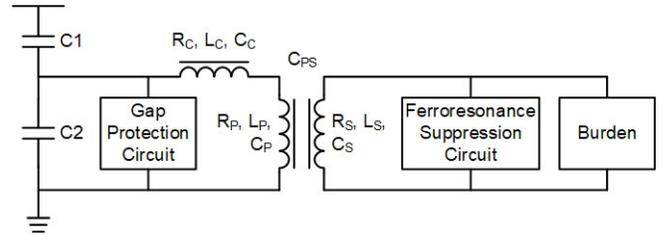
Fig. 1. Generic CCVT model

Coupling-capacitor voltage transformers (CCVTs) are generally used at transmission-level voltages (138 kV and up) to provide secondary voltage signals to relays. This is because they are more cost-effective than wire-wound potential devices rated for full system voltage. The idea behind a CCVT is to use a capacitive voltage divider to step down the voltage before feeding it into a wire-wound VT that is rated much lower than the full system voltage. While a CCVT is more economical than a wire-wound VT, it is a complex device consisting of a tapped stacked of capacitors, a tuning reactor, a wire-wound VT, a gap protection circuit, and a ferroresonance suppression circuit (active or passive). Fig. 1 shows the basic structure of a CCVT [1].

unknown, it can be simulated by temporarily shorting the gap protection circuit shown in Fig. 1 at the time of the fault for one-quarter of a cycle. This simulates the gap shorting at a peak capacitive voltage and then opening at a capacitive zero crossing. Fig. 11 shows the results of this simulation.

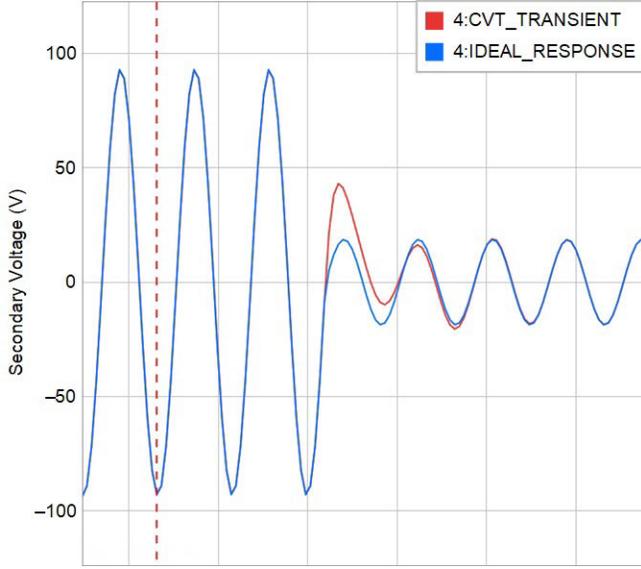
Fig. 2. Transient response of active ferroresonance suppression circuit

The worst case of CCVT transient overreach occurs at a voltage zero crossing because this is the moment in which the capacitor has the highest amount of stored energy. Fig. 2 shows a CCVT transient from an active ferroresonance suppression circuit compared with the ideal response.

Once the signals in Fig. 2 have been run through the relay filtering, the magnitudes can be extracted. For comparison, Fig. 3 shows the half-cycle filtered voltage magnitude and the full-cycle cosine voltage magnitude compared with the ideal response in magnitude. The view is zoomed in to show the CCVT overreaching transient.

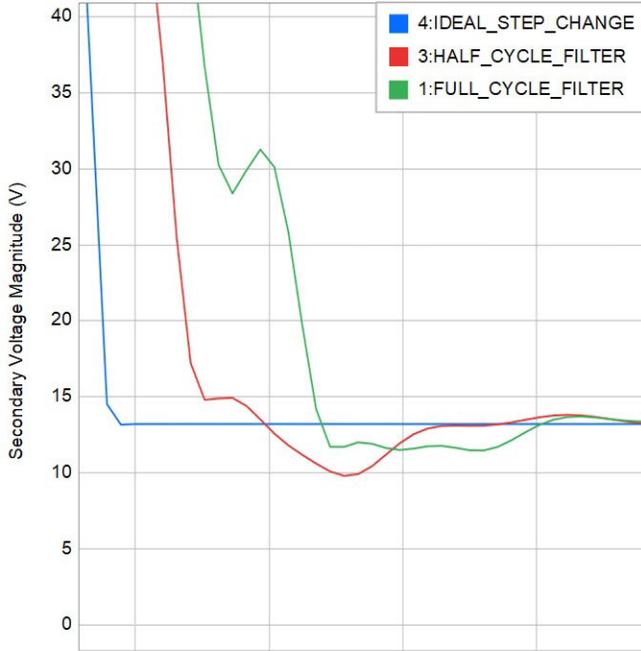
Fig. 3. Full-cycle cosine and half-cycle filtered voltage magnitudes

Fig. 3 shows that both filtering methods eventually overshoot the expected voltage. What is not usually discussed in the literature is that both filtered voltages are actually more secure than the ideal response leading up to the overshoot. Fig. 4 shows the filtered response from the fault inception before the overshoot occurs.

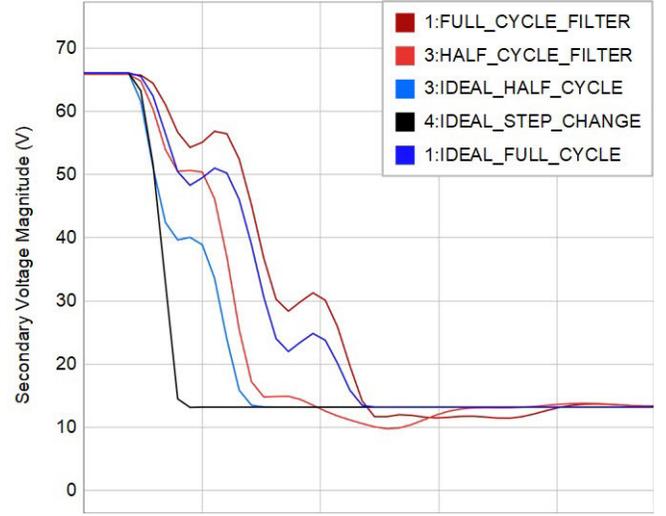
Fig. 4. Filtered response to CCVT transients

Fig. 4 shows that prior to the overreach, the CCVT filtered signals overestimate the voltage compared with the ideal response of the respective filter. This shows that CCVTs initially provide a secure voltage estimation but then follow up with a nonsecure voltage estimation.

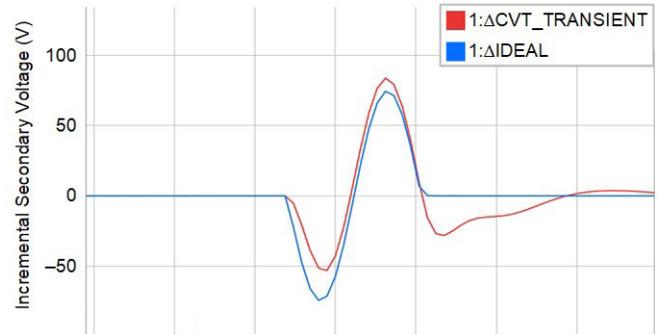
Fig. 5. Incremental voltage response

Fig. 5 shows a comparison between the ideal incremental response and the actual incremental voltage response from the waveforms in Fig. 2.

The CCVT response initially produces a smaller-than-expected Δv and the element underreaches for about the first half-cycle of the event. For the second half-cycle, Δv is slightly larger than expected and can produce a small relay overreach. As long as the high-speed relay is shut down prior to the introduction of the overreach, it is inherently secure.

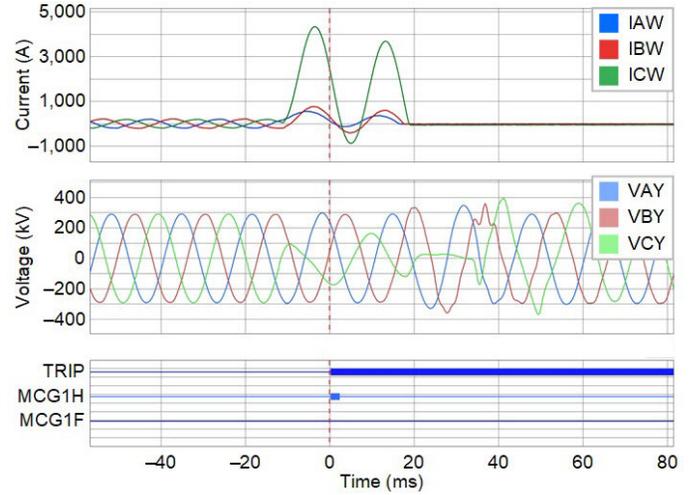
Fig. 6. High-speed element overreach

Fig. 6 shows an example in which a traditional full-cycle filtered element restrained for a fault (MCG1F) while the half-cycle filtered high-speed element led to an overreach (MCG1H). The line length is 36 miles, and the fault occurred about 45 miles from the relay location. The Zone 1 reach of the filtered elements was set at 85 percent of the line, and the high-speed elements were factory-set at 80 percent of the filtered element Zone 1 reach, which in this case is 68 percent of the total line length. The known fault location and relay settings indicate a significant overreach of the high-speed elements. The SIR for the system is 2, so the relay user elected to turn the CCVT transient detection logic off (the relay was set with ECVT = N).

At the moment the current began to increase, the VC voltage amplitude had just transitioned from negative to positive, which indicates that the phasor (Vc) rotated across the 0 degree threshold. This means that the dc offset defined by the second term in (2) will be positive, which agrees with the plot.

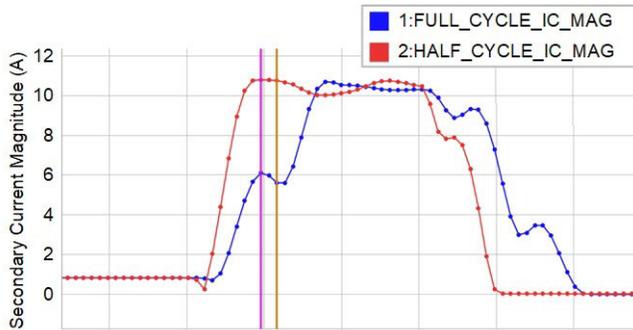
Fig. 7. IC magnitude (full-cycle filtered and half-cycle filtered)

Fig. 7 compares the full-cycle filtered and the half-cycle filtered IC current magnitudes to illustrate that there is no current overshoot in either signal, which is quite impressive given the known dc offset in the original signal. As a reference, the two vertical cursors show the time during which the high-speed element was asserted in the relay.

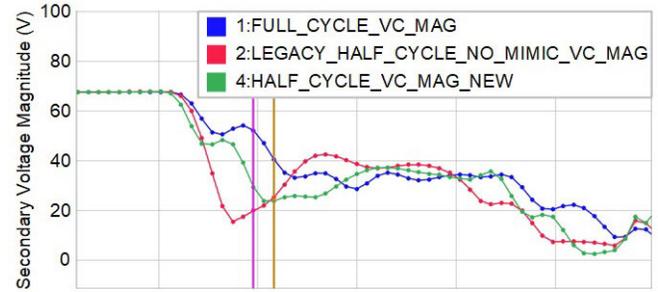
Fig. 8. Comparison of various VC filtered values

Fig. 8 shows the plot of the full-cycle filtered, the legacy half-cycle filtered (with no mimic filter), and the new half-cycle filtered VC magnitudes. Again, the two cursors show the time during which the high-speed element asserted.

Fig. 8 shows that the legacy half-cycle filtered element with no mimic filter, which is used when $ECVT = N$, had the most overshoot. This was the voltage signal used by the mho element at the time of the trip.

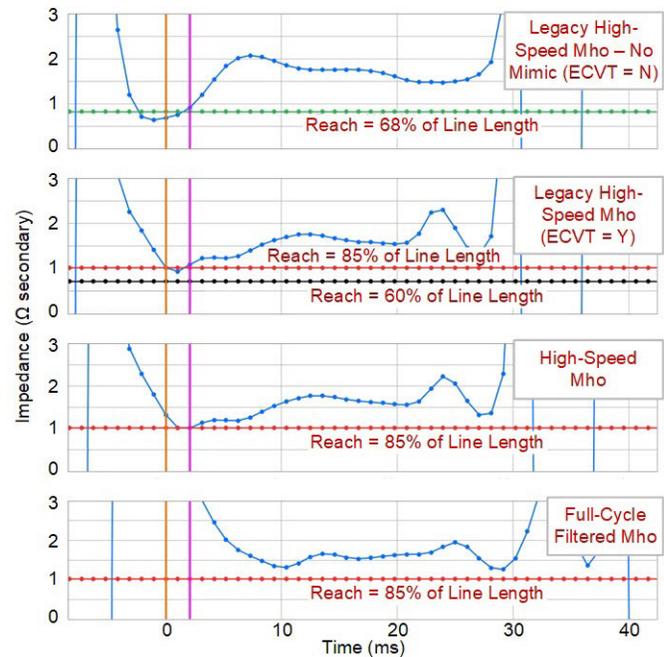
Fig. 9. CG mho element evaluations

In Fig. 9, we evaluate the CG mho element four times using the four different filtering methods discussed previously. Recall that the mimic filter is always used on the current signal, but in the legacy implementation, the mimic filter is used on the voltage signal only if $ECVT = Y$. In the new high-speed element, the mimic and low-pass filters are used on both the voltage and current signals.

The bottom section of Fig. 9 shows that the full-cycle filtered mho element restrained for this fault. In fact, at the time of the trip (marked by the orange cursor) the calculated CG impedance of the full-cycle filtered element was 4.14 ohms, which is four times larger than the set reach of 1.02. The lowest impedance seen by the full-cycle filtered mho element was 1.33 ohms, which is about 30 percent beyond the Zone 1 reach.

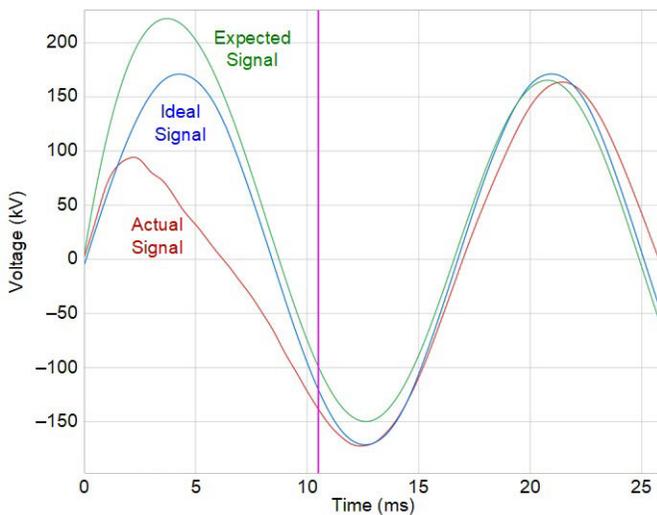
Fig. 10. Comparison of ideal, expected, and actual CCVT performance

After the evaluation of the high-speed mho elements, it may be tempting to set ECVT = Y if using the legacy high-speed elements or to upgrade to the new high-speed elements and consider the problem resolved. However, even though either course of action will prevent misoperation for this case, the CCVT is not performing as expected. Fig. 10 compares three voltages at the initiation of the fault: the ideal ratio voltage (blue), the expected CCVT performance (green), and the actual CCVT performance (red). The expected signal was generated from an Electromagnetic Transients Program model of an active ferroresonance suppression circuit CCVT (low-C model in [7]). This model closely matches the CCVT in service at the time of the fault.

From Fig. 10, it is clear that the CCVT severely underestimated the voltage signal initially, while we expected it to overestimate. While the exact cause of this transient is

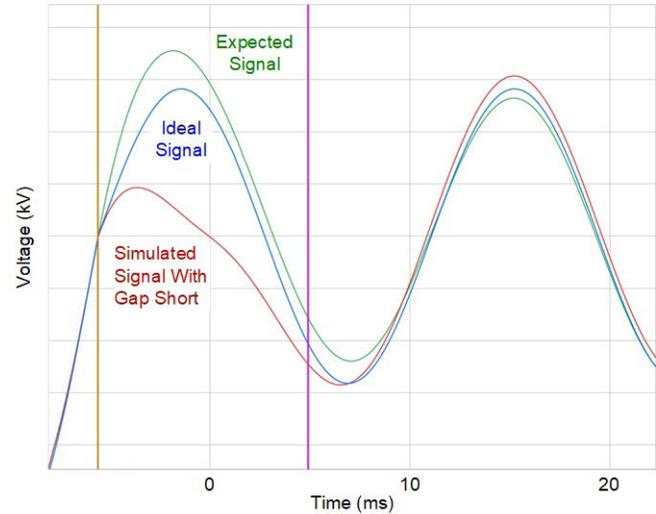
Fig. 11. Result of shorting gap protection on CCVT

Fig. 11 shows that a failing gap protection circuit could explain this transient. Shortly after this event, the CCVT was replaced and, unfortunately, the gap protection circuit of the original CCVT was not examined.

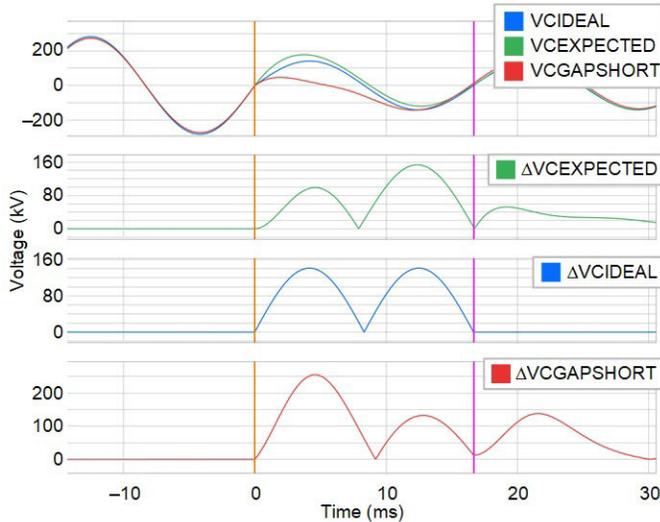
Fig. 12. Incremental quantities of expected signal (green), ideal signal (blue), and gap short signal (red)

Fig. 12 shows that the incremental quantities provide a clear view of the performance of the CCVT for the first cycle of the fault. The blue line shows that, ideally, there is no offset in the signal. The green line shows that we can expect an incremental quantity with a first peak that has a lower magnitude than the second peak. Relays that use incremental quantities tend to underreach for the first half-cycle of an event as they take advantage of the inherent security of the initial CCVT transient. The red line shows the incremental voltage for a failing gap. The initial peak magnitude is much greater than the second peak magnitude. This indicates that the relay connected to the CCVT had an additional low-resistance shunt path that altered the voltage signal.

These signals are easy to acquire using event analysis software. In time-domain relays, the incremental signals are available directly from the relay, allowing for easy visual inspection of the CCVT transient performance. Tracking these signals for events over time can alert a user to a poorly performing CCVT.

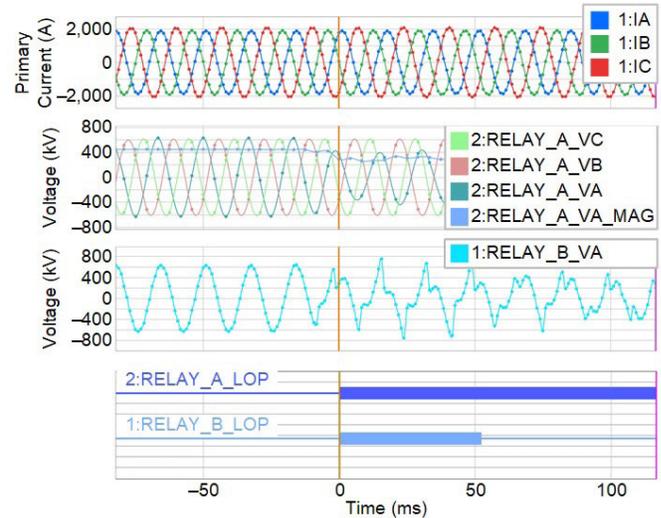
Fig. 13. Initial failure of CCVT on Phase A voltage

The unfiltered voltage in Fig. 13 shows that the voltage signal from the CCVT became corrupted. Harmonic analysis performed on the signal shows that the total harmonic distortion went from 0 percent prior to the relay LOP assertion to 40 percent after the LOP assertion. While the unfiltered signal shows that there is an issue with the Phase A voltage, the filtered signal (which contains only the 60 Hz content) shows a less dramatic change. The filtered VA signal reduced in magnitude from 445 kV to about 290 kV, and a 20 degree phase shift was introduced.

Fig. 13 shows that the Relay B protection elements that rely on voltage are vulnerable due to the deassertion of the LOP logic. In fact, nearly two seconds after the LOP deassertion in Relay B, the Zone 1 distance elements asserted, issuing a trip to the circuit breaker and isolating the line (Fig. 14). By this time, the filtered VA magnitude had declined to about 160 kV.

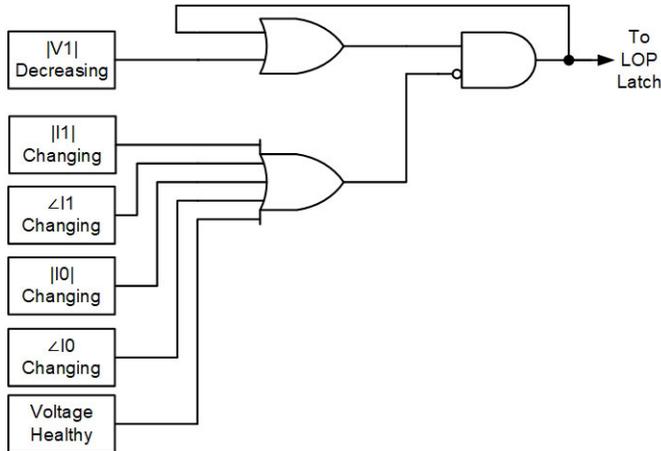
Fig. 15. Simplified LOP logic

In (4) and (5), there are magnitude and angle checks to determine if I_1 or I_0 have changed. From this, Fig. 15 shows the incremental phasor change LOP logic, which has been simplified by removing ancillary logic.

In Fig. 15, we also added a seal-in, since an incremental voltage change is only temporary. Without the seal-in, the LOP bit would only be able to assert for the length of the incremental quantity window, which in this case is one cycle.

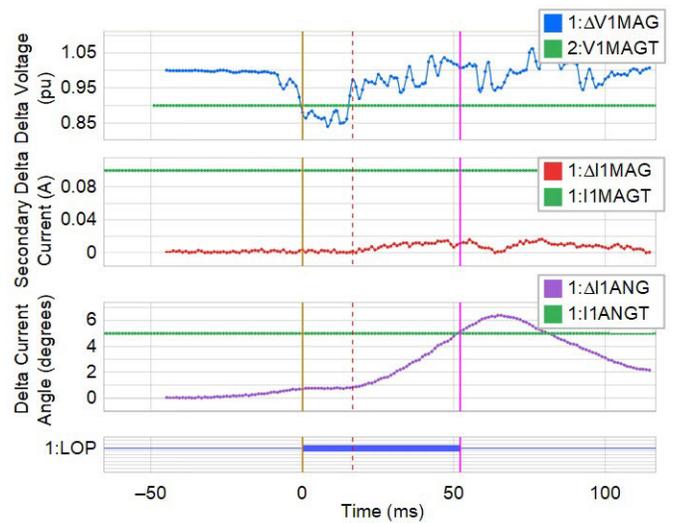
Fig. 16. Relay B LOP incremental quantities

We now look at the relevant quantities from each relay for the initial declaration of an LOP condition. To measure the incremental quantities correctly, we need to subtract the sample value from one cycle prior from the present sample value. The event analysis software that used allowed multiple events to be analyzed simultaneously. The event from Relay B was added it to the software twice. The first event provided the k values (current samples), and the second event was added with a $k-1$ (1 cycle prior) time shift. The results are shown in Fig. 16, with the three analog axes in order from top to bottom with their corresponding thresholds: $\Delta|V_1|$, $\Delta|I_1|$, and $|\Delta\text{ang}(I_1)|$. At the bottom, the digital axis shows the assertion and deassertion of the LOP bit. The zero-sequence incremental quantities are not shown because there was not enough zero-sequence current available to enable the zero-sequence blocking logic. The events from Relay B are filtered and sampled at 16 samples per cycle.

Fig. 16 shows that the ratio of $|V1_k| / |V1_{k-1 \text{ cycle}}|$ (DV1) did go lower than 0.9 (V1T), indicating that there was enough change in V1 to allow an LOP assertion. However, it did not exceed this threshold by much. The lowest recorded DV1 was 0.85, which means there was a 15 percent change in V1. This is only 1.5 times the necessary 10 percent change.

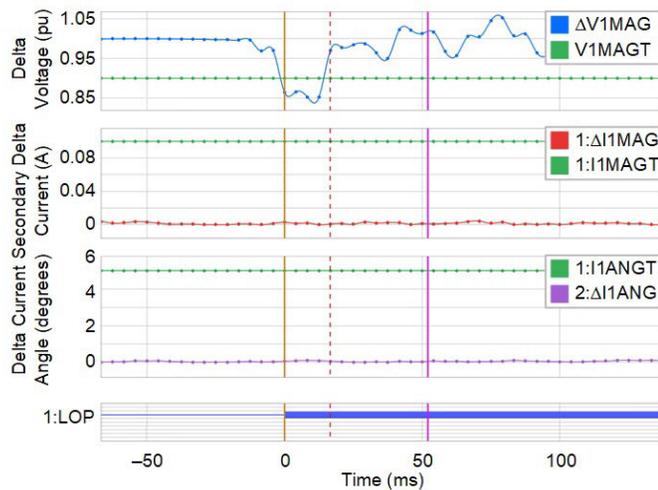
Fig. 17. Relay A LOP incremental quantities

The pertinent incremental quantities for Relay A, which was looking at the same voltage and current signals, are shown in Fig. 17. The events from Relay A are filtered and sampled at 4 samples per cycle.

Aside from the higher resolution available from the event reports in Relay B, the Relay A DV1 signal looks similar to that of Relay B. However, DI1ANG did not change in Relay A, which prevented the LOP bit from being blocked in Relay A. This analysis of incremental quantities shows that Relay B saw a change in the I1 angle while Relay A did not. The question is, why?

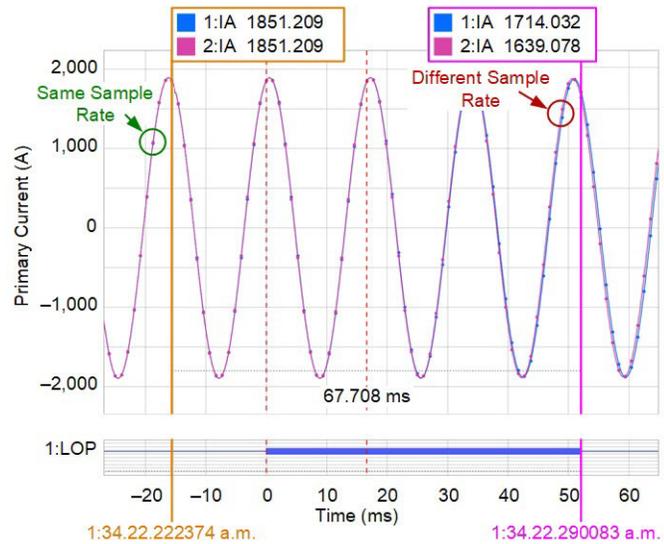
Fig. 18. Relay B IA_k and $IA_{k-1 \text{ cycle}}$ signals

Based on a closer inspection of the $I\Phi_k$ and $I\Phi_{k-1 \text{ cycle}}$ signals (where $\Phi = A, B, \text{ or } C$) from Relay B, it appears that all of the current signals were sampled at a slightly different part of the sine wave shortly after the LOP condition was detected. Fig. 18 shows only the IA_k (blue) and $IA_{k-1 \text{ cycle}}$ (purple) currents for simplicity.

We expect that even if these two signals are one cycle apart in time, they would still look exactly the same and be sampled the same. This is true for the left side of the plot, before the LOP condition occurred.

Shortly after the LOP condition was declared by the relay, the IA_k samples appear to occur before the $IA_{k-1 \text{ cycle}}$ samples on the sine wave. This means that the time difference between IA_k and $IA_{k-1 \text{ cycle}}$ is actually less than one cycle. Since the time differential between the two signals is not equal to one cycle,

the quantity DI1ANG is no longer equal to zero. In this case, the signed value of DI1ANG evaluates to about -6 degrees at the peak of the calculation, indicating that $|I1_k|$ is lagging $|I1_{k-1 \text{ cycle}}|$.

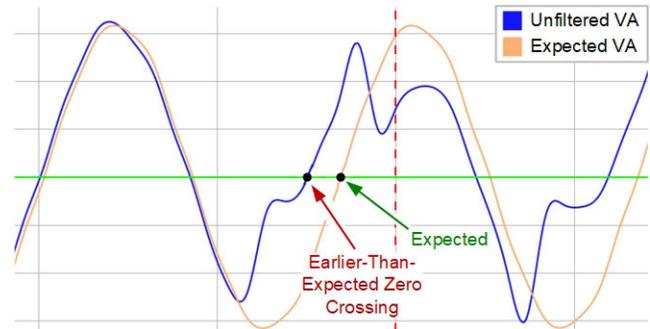
Fig. 19. Relay B unfiltered VA voltage and expected VA voltage

In Relay B, the sampling rate of all the signals is determined by the frequency tracking algorithm, which relies on the VA signal. The relay looks at the time between the zero crossings of the signal to determine the frequency [9]. For a 60 Hz signal, zero crossings should occur every 8.33 milliseconds. Fig. 19 compares the expected voltage and the actual voltage from Relay B. The actual voltage made a zero crossing well before the next zero crossing was expected to occur, which indicates an abrupt change in frequency.

at 61 Hz leads to a 6 degree angular slip over the time period of the 60 Hz signal (16.6 milliseconds). This 6 degree difference between the incremental quantities continues until the sampling rate of the relay agrees with the frequency of the signal the relay is trying to sample. Fig. 16 shows that toward the end of the event, DIANG is reducing. This indicates that the sample rate of the relay is correct for the signal provided. The VA voltage, after the initial failure, does tend to have zero crossings closer to the expected 8.33 milliseconds for a 60 Hz signal.

Relay B had a new firmware revision that caused it to ignore large changes in frequency, thus preventing these changes from influencing the sample rate of the relay. This may have prevented the LOP bit from deasserting in this case. It is a good practice to keep relay firmware up to date.

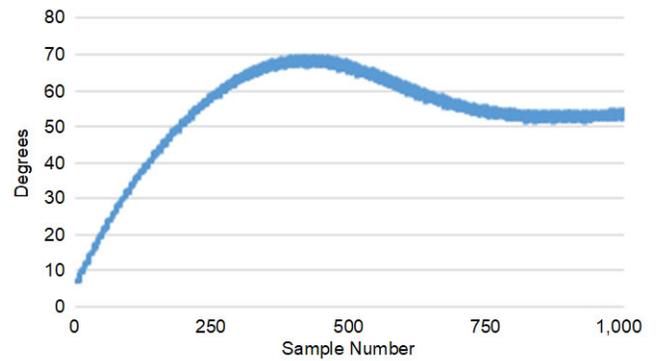
Fig. 20. $\text{ang}(VImem) - \text{ang}(V)$

Under load and most fault conditions, the phasor VAB and the phasor VABImem are in phase with each other. However, if the frequency tracking of the relay is incorrect, then the two phasors slip from each other as time progresses. This situation is more drastic than the angular displacement experienced with an incremental quantity. In incremental quantities, the memory of the signal is only one sample from one cycle prior, and it is weighted equally to the present sample. A slip in the sampling frequency can directly be related to the phase angle error in this case. Memory voltage, however, heavily weights previous information over present information using an infinite input response. Because past information is weighted so heavily, it takes time for the memory signal to adapt to changes in the sampling frequency. Because of this, the slip between a signal and its memory produces a cumulative slip over time before stabilization is reached. Fig. 20 shows the angular displacement between a signal (V) and its memory (Vmem) as time progresses.

V is a 60 Hz signal that is sampled at 61 Hz with 16 samples per sample period. Vmem is defined in (7).

In this case, the angular displacement stabilizes at about 55 degrees after the frequency tracking error is introduced. This demonstrates that correct frequency tracking is crucial in elements that use weighted signal memory. The situation can become even worse if the frequency tracking is changing erratically due to a failing voltage potential, which is likely in this particular event.

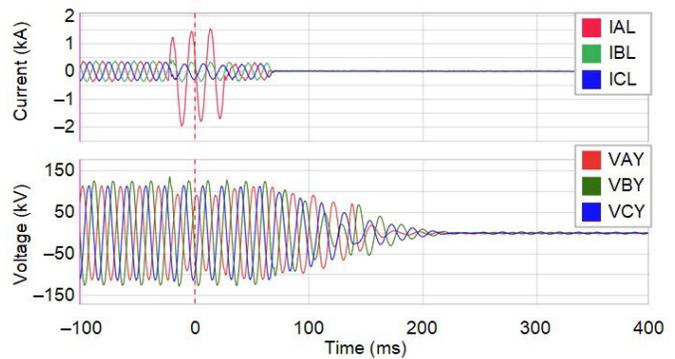
Fig. 22. Simplified oscillographic view of event showing voltages and currents

During the fault, the Phase A current increases to approximately 1,500 A and the Phase A voltage is slightly depressed, as shown in Fig. 22. A closer look at the event report and digital bits in Fig. 23 shows the directional element (32GF) incorrectly asserting and then a trip asserting shortly after IN105 drops out. IN105 is the blocking signal from the remote line relay, and these relays form a DCB scheme. When IN105 drops out, after a short carrier coordinating delay, the trip bit 3PT asserts.

Very close inspection of the voltages in either Fig. 22 or Fig. 23 shows that VB is slightly larger than VA or VC, even during the period of the event report before the fault occurs. If we plot only the voltage magnitudes, as in Fig. 24, we can clearly see a more pronounced difference in VB (the blue trace). It is approximately 11 percent higher than the VA and VC voltages.

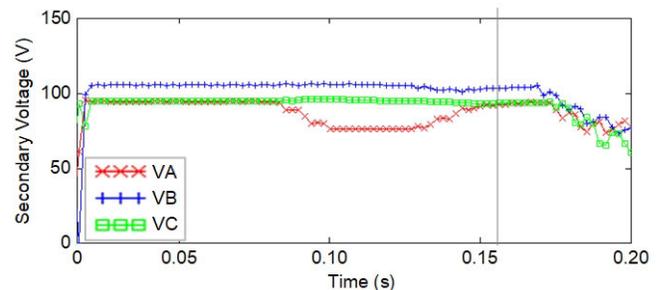
Fig. 24. Voltage magnitudes

We now know that the directional element incorrectly declaring a forward direction ultimately caused the trip. In addition, we see an abnormally high voltage on Phase B.

However, further review of the settings (not detailed here for the sake of brevity) proved that no reasonable settings adjustments could have prevented the relay from declaring this a forward fault. If it is not an algorithm error, relay hardware error, or relay settings error, then what is the root cause? The errant magnitude shown in Fig. 24 offers a hint.

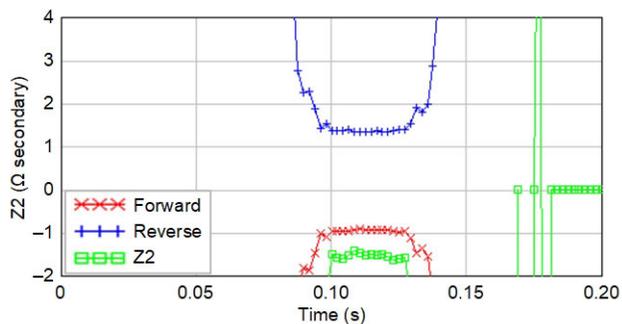
Fig. 25. Calculated Z2 against forward and reverse thresholds

Fig. 25 shows the calculated Z2 value against the forward and reverse thresholds. The calculated value (green trace) is below the forward threshold (red trace) during the time period the fault occurred, which is consistent with a forward fault directional decision.

Fig. 28 clearly shows that the calculated value (green trace) is now plotting above the reverse threshold (blue trace) on the graph. If we compare Fig. 28 with Fig. 25, they almost look exactly opposite.

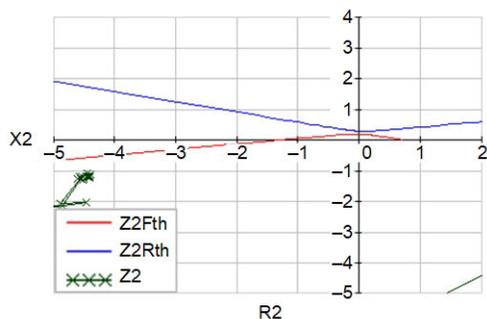
Fig. 26. Negative-sequence directional element thresholds on R-X diagram

Fig. 26 shows the directional element on an R-X diagram and confirms a forward directional decision. We expect the calculated impedance for a reverse fault to be on the opposite side of the graph on the positive portion of the y-axis.

This clearly indicates that the directional element and relay operated as designed. The directional relay settings used an “automatic” calculation, which is described in detail in [12].

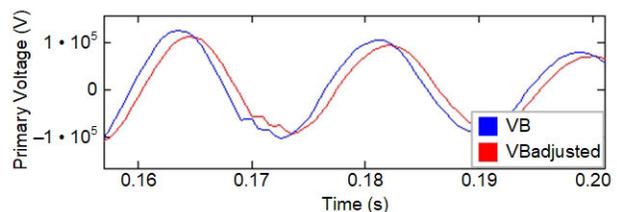
Fig. 27. Corrected and uncorrected Phase B voltages

Fig. 27 compares the uncorrected and corrected Phase B voltages. There is not much of a difference between the two.

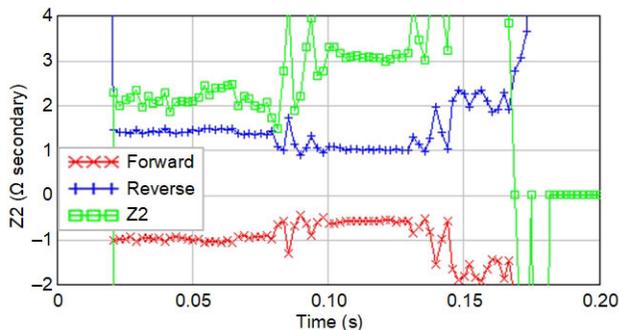
Fig. 28. Response of negative-sequence directional element with corrected Phase B voltage

We use the corrected Phase B voltage to calculate the sequence quantities and then use the updated values to see how the negative-sequence directional element responds. Fig. 28 shows the results of the Z2 calculation and the forward and reverse thresholds using the corrected Phase B voltage.

The “error” in the Phase B voltage was substantial compared with the negative-sequence voltage generated by the fault. While the fault caused the Phase A voltage to collapse, the errant negative-sequence Phase B voltage was almost the same in this case and ultimately caused the directional relay to declare a clear reverse fault as a forward fault.

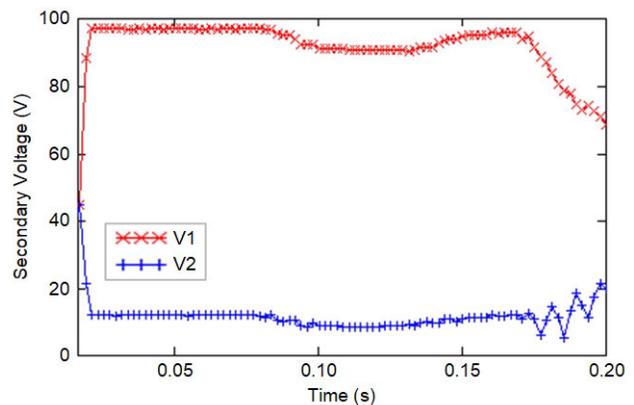
Fig. 29. Positive- and negative-sequence voltage magnitudes

The negative-sequence voltage magnitude was around 10 V secondary. A simple negative-sequence overvoltage element set at approximately 6 V with a time delay of several minutes would have been sufficient to catch this CCVT failure. Ultimately, a scheme was implemented that used both a simple negative-sequence overvoltage element and a simple scheme that compared the magnitudes of two of the phase pairs ($|VA| - |VB|$ and $|VB| - |VC|$). The overall scheme was qualified with a very large time delay, on the order of two minutes. A simplified logic diagram of the scheme is shown in Fig. 30.

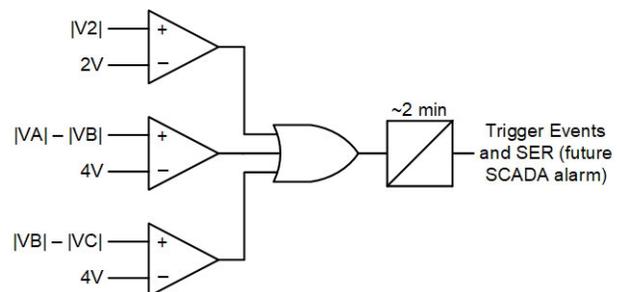
Fig. 30. Simplified diagram of alarm logic

During balanced power system conditions, none of these elements should be asserted. The units in Fig. 30 are in secondary volts, and they are set quite sensitively. The time delay is long enough to avoid assertion during power system faults or transient conditions. The thresholds are set with sensitivity in mind and equate to approximately 3 to 6 percent of the nominal system voltage. Care must be taken to ensure that they are set above the normal power system voltage unbalance; historical load measurements are crucial to setting an alarm like this. Locations and voltage levels in the power system where the voltage unbalance is not tightly regulated require an increased pickup value, which decreases the sensitivity of the alarm to standing CCVT error.
